Modeling the Depth of Surface Cracks in Brake Disc

Abstract: The article presents the state of knowledge and research in the field of surface cracks occurring in disc braking systems of rail and car vehicles. The craze formed during the operation of vehicles is particularly dangerous and leads to breaking the disc into several pieces. It may lead to a loss of braking force and damage to the entire disc brake caliper. The main aim of the research is to identify surface cracks in brake discs made of cast iron and use experimental methods to estimate their depth. Research were conducted on the disc braking system developed by the authors. In examining the location and depth of cracks, the penetration method, ultrasound, as well as a special probe were used. This device measures the crack depth based on the electrical resistance between two points on the surface of the metallic object. The tests showed that the first microcracks on the brake discs appeared after 309 braking tests on the test stand. In addition, it was observed that the surface cracks length of the disc increased linearly to depth until they reached about 11.5–12 mm with corresponded to crack lengths in the range of 65

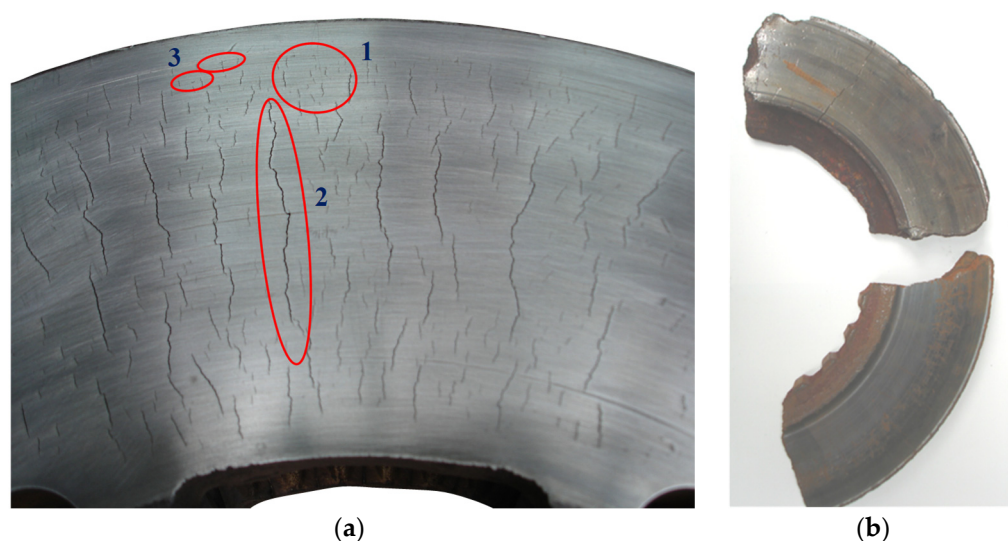
Figure 1. View of a damaged brake disc: (a) cracks on the friction surface of the disc; 1—microcracks, 2—radial cracks, 3—circumferential (longitudinal) cracks, (b) view of fragments of a cracked brake disc.

In [9], three basic surface cracks were distinguished, caused by thermal and mechanical stresses in the friction ring of the disc. These were microcracks, radial cracks and circumferential cracks, which the authors of this article also observed during their own observations and research. However, circumferential cracks are rare and circumferential scratches are more common. Circumferential cracks are caused by the penetration of hard debris between the cladding and the disc, such as sand grains from a track or road. Scratches are not related to thermo-mechanical phenomena occurring during braking. The number of circumferential cracks in long-term operation changes due to the phenomenon of abrasive friction. Some of the scratches are ground in subsequent braking and new ones appear. A view of a brake disc with various failures and an example of the disc fragments after its fracture are shown in Figure 1.

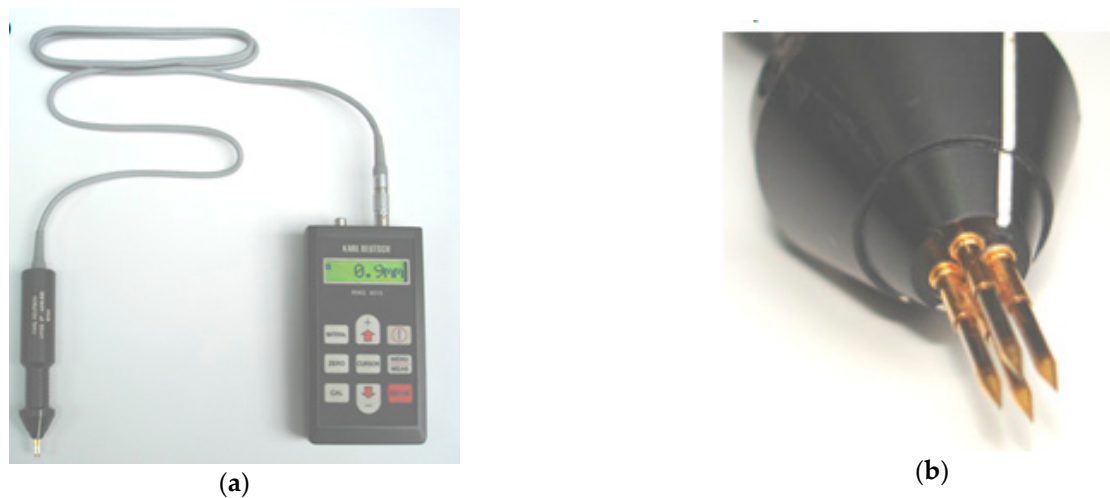
Figure 4. Instrument for crack depth measurement, type RMG 4015, made by Karl Deutsch: (a) general view and (b) head for cracks perpendicular to the surface.

Figure 4 shows a surface crack depth Karl Deutsch measuring instrument (Karl Deutsch GmbH, Wuppertal, Germany), with a perpendicular cracking head.

The probe shown in Figure 4b is four-pole in a square configuration and consists of two current and two measurement poles. The tips of the probe in relation to the pilot sleeves are elastically mounted and made of hardened steel, which ensures good electrical contact with the test object. In addition, the measuring probes are also available in a four-pole system with poles arranged in series to measure cracks occurring at an angle to the surface (plane) of the object.

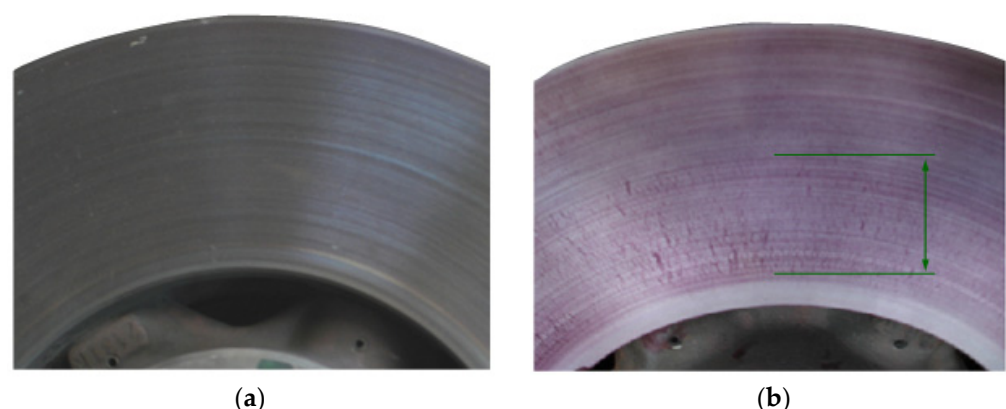
Figure 5. Condition of the friction surface of the T1 (Nodular Cast Iron) disc after the first braking: (a) before penetration testing and (b) after penetration testing (place of cracks marked green).

Bench tests of brake discs after 309 brakings, combined with non-destructive (penetration) tests, showed that surface cracks appeared on new discs after several hundred braking operations. The first microcracks in the area of the inner diameter of the disc are visible only with the use of penetration tests, as shown in Figure 5. Further braking on the test bench disclosed the first cracks (3 cracks) with a length not exceeding 7 mm, visible to the eye, and are shown in Figures 5 and 6.

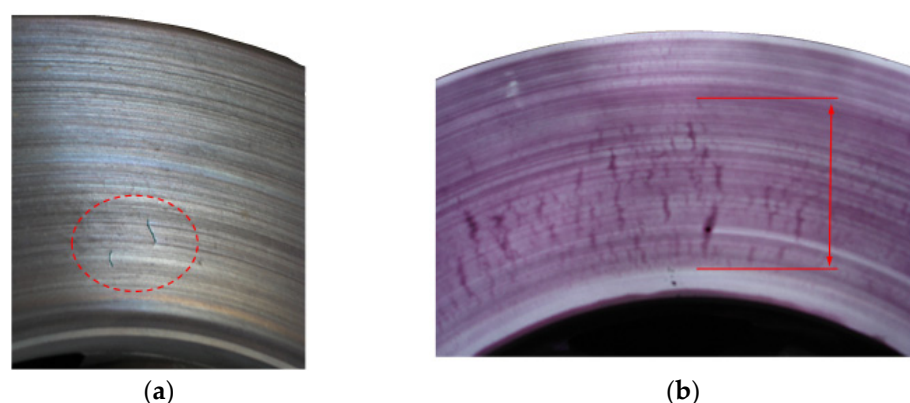
Figure 6. T2 (Grey Cast Iron) disc surface condition after successive braking (places of cracks marked red): (a) before penetration testing and (b) after penetration testing.

The brake discs were tested according to the schedule presented in Table 1. The appearance of the first surface cracks on the T2 disc was related to the grade of cast iron and the composition of the chemical elements (additives). In the case of the disc T2, gray cast iron was used, while disc 1 was made of nodular cast iron. The chemical compositions as a percentage of additives are presented in Table 2. The discs were not subjected to thermo-chemical treatment.

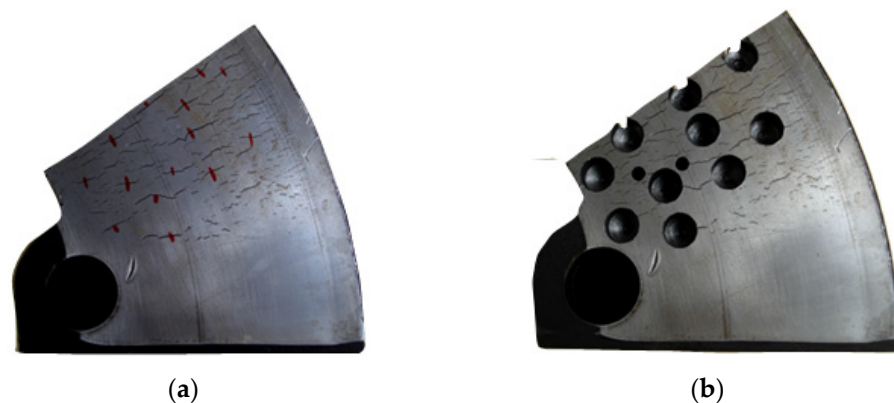
Figure 7. View of the 610 mm \times 110 mm brake disc segment: (a) with the red half-crack line marked, (b) with blind holes to observe the crack depth.

For the friction ring segment of the 610 mm × 110 mm-type brake disc, holes were made in several microcracks in the middle of their lengths, which is shown in Figure 7. Thanks to this, it was possible to observe the actual crack depth and the crack shape. The cracks shown in Figure 7a were measured prior to making the blind holes.

On 14 marked microcracks on the brake disc section (Figure 7a), and the crack depths measured with the RMG 4015 device, as well as those verified with the GEKON ultrasonic flaw detector, the relative percentage error of the measurement with the RMG 4015 device was in the range of 9–16%. Taking this into account, it was concluded that the RMG 4015 device can be used in measuring the depth of cracks at the surface of brake discs of rail vehicles.

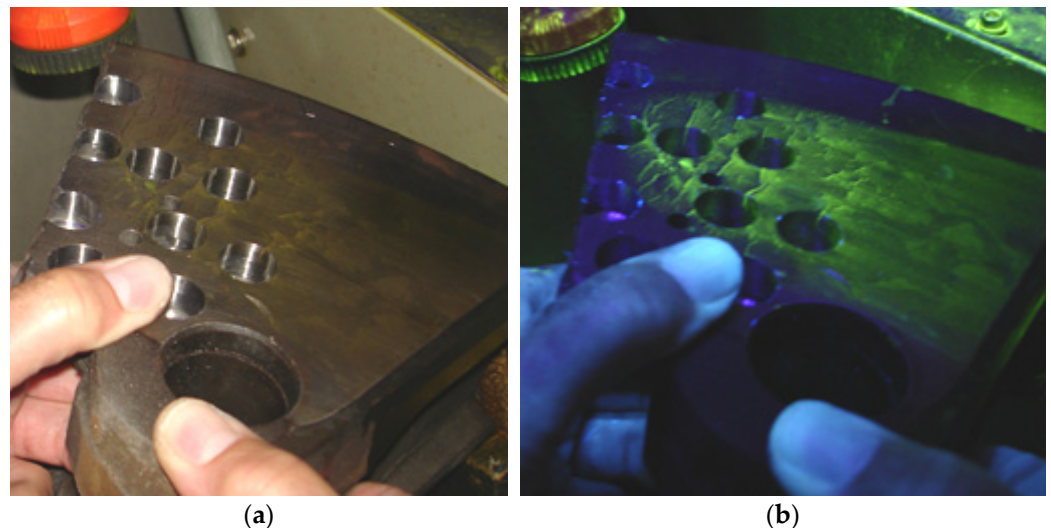
Figure 8. View of the brake disc section 610 mm \times 110 mm: (a) before magneto-particle tests, (b) during tests.

Additionally, in order to better observe the shape of the crack cross-section and its depth, magneto-particle tests were performed and the result are shown in Figure 8.

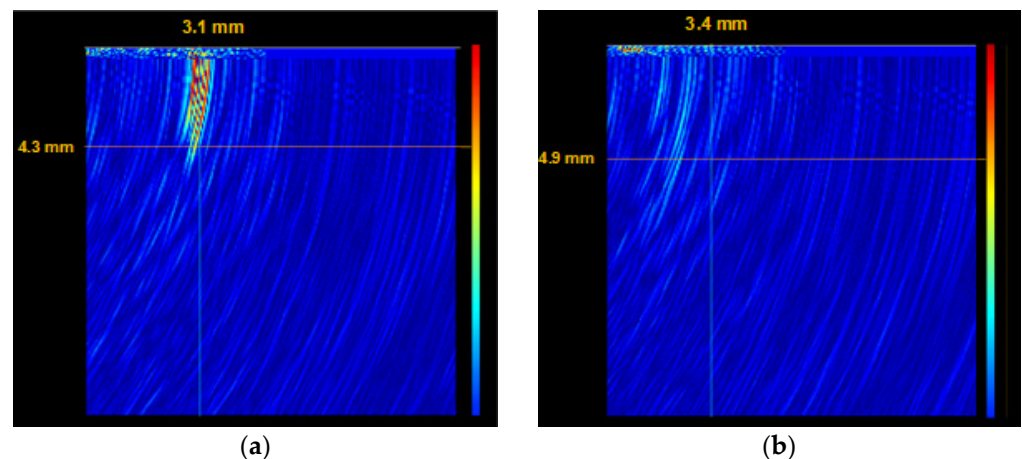
Figure 9. View of the cross-section of selected microcracks of the brake disc section obtained with the GEKON ultrasonic flaw detector: (a) crack with a depth of 4.3 mm and (b) crack with a depth of 4.9 mm.

Then, the cracks indicated in Figure 7a were examined using the ultrasonic method with a GEKON (Karl Deutsch GmbH, Wuppertal, Germany) ultrasonic flaw detector to assess the depth of the crack. Figure 9 shows two selected visualizations of the crack depth.

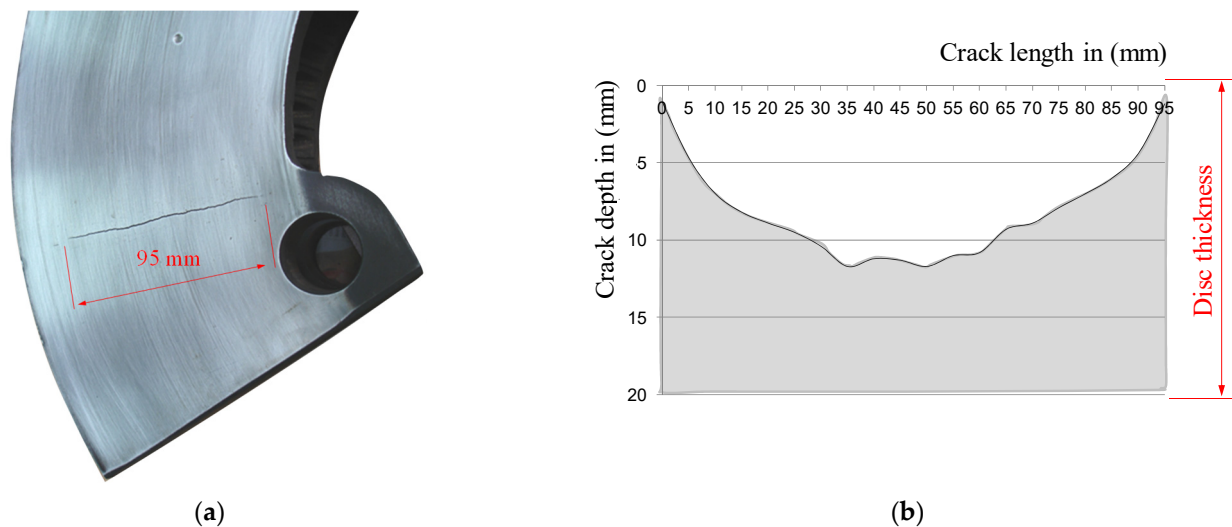
Figure 10. One-sided crack on the ring of the railway brake disc: (a) view of the crack and (b) the relationship between the length of the crack and its depth, measured with the RMG 4015 device.

Then, the depth of surface cracks was measured on subsequent parts of the brake discs, every 5 mm of the crack length. Figures 10 and 11 show the results of testing the depths of selected surface cracks using the potential probe of the RMG 4015 instrument, along with the view of these cracks.

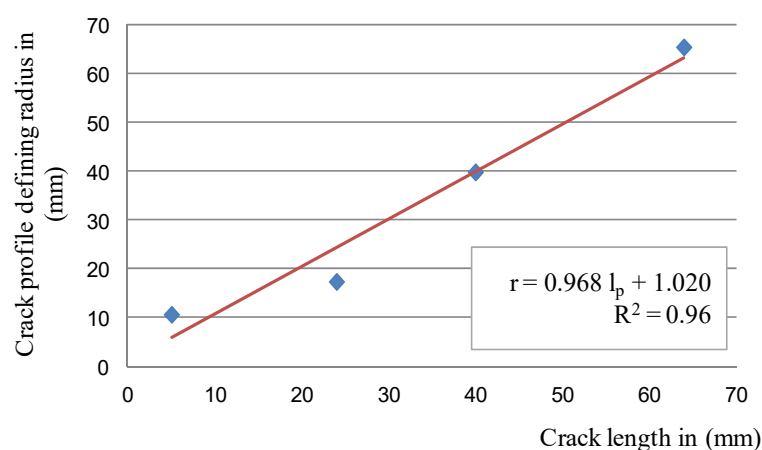
Figure 14. The relationship between the radius of the arc defining the crack depth and its length; blue—radius values for individual cracks determined from the regression functions of circles, red—linear regression for these values.

$$r = 0.968 \times l_p + 1.020 \quad (3)$$

Dependencies (3) and (5) are shown in Figures 14 and 15.

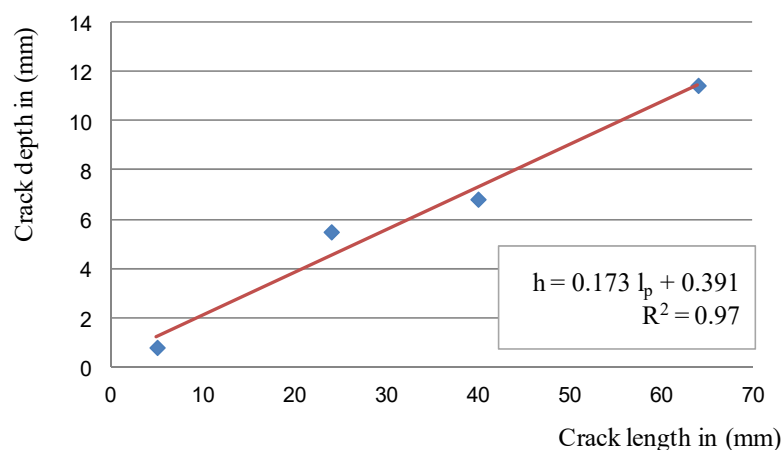
Figure 15. The dependence of the depth of the crack on its length; blue—depths determined from the regressive functions of circles, red—linear dependence of the crack depth on its length.

$$g_p = r + b = 0.173 \times l_p + 0.391 \quad (5)$$

The designated regression functions for estimating the depth of the crack give high coefficients of determination R^2 at the level of 0.95–0.97, which proves that the model is well-adjusted to the measurement results. Thus, it can be concluded that the depth of surface cracks, up to 70 mm long, on cast iron brake discs can be determined by simply measuring their lengths.

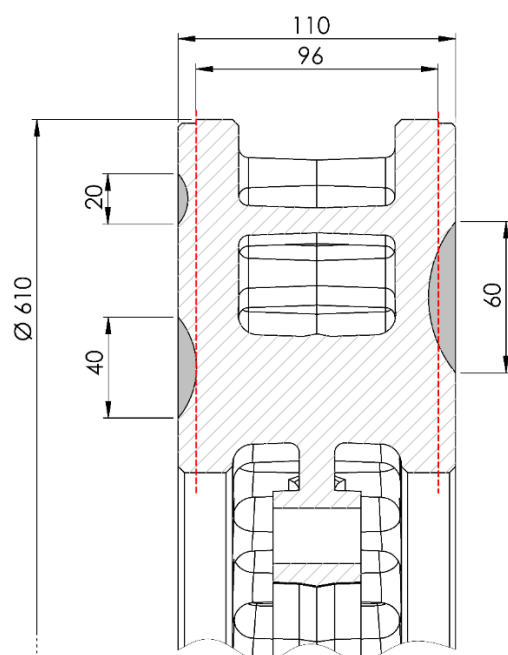
Figure 16. Visualization of three cracks with lengths of 20, 40 and 60 mm on the surface of the fragment of brake disc with dimensions of 610 mm \times 110 mm; the red line marks the minimum thickness of the brake disc (96 mm).

Conducted research and analysis of the results allowed for the creation of a simple tool enabling an easy assessment of the technical condition of the brake disc in terms of its suitability for regeneration and further operation. Figure 16 shows examples of 20-, 40-, and 60-mm-long crack cross-sections in a brake disc, with a nominal size of 610 mm × 110 mm, the permissible reduction in the friction ring thickness is 7 mm on each side of the disc.

The longest of the cracks, according to the model, reaching a depth of 10.77 mm, excluded the disc from further use. Even if the disc is regenerated to the minimum thickness, the crack will not be completely eliminated. Shorter cracks, respectively, 3.85 and 7.31 mm in depth, provided that no more serious damage occurs in the remaining cross-sections of the friction rings, could be eliminated using appropriate surface treatment of the disc.

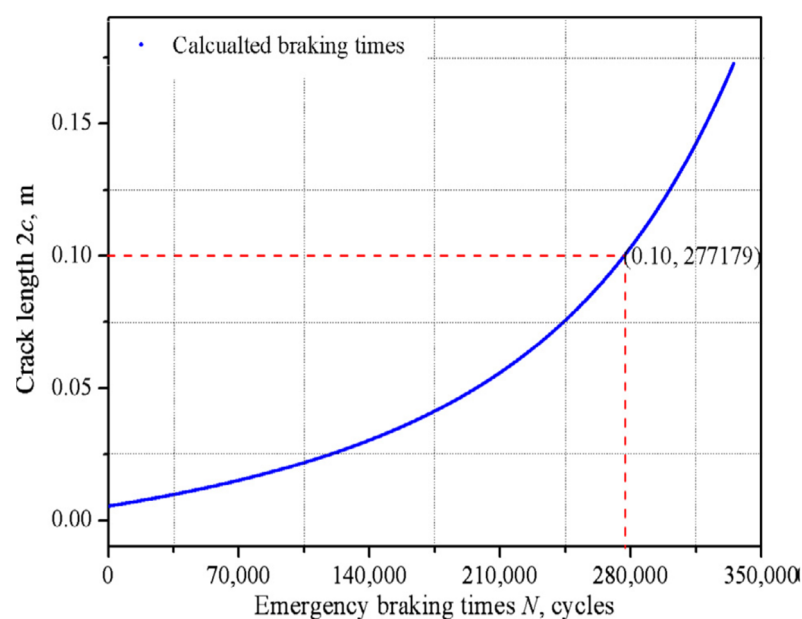
Figure 17. Expected crack length depending on the number of emergency braking cycles performed; the limit crack length of 100 mm was reached in this case after 277,179 braking cycles [8].

As indicated in [8], the increase in the crack length with each braking is the greater, the longer the crack is (Figure 17). Therefore, a reasonable solution would be to regularly turning the brake discs with a small repair dimension in order to eliminate still relatively short cracks; at most a few millimeters. Such a procedure would prevent the penetration of the fracture into the ring cavity due to the ever-faster propagation, thus extending the life time of the brake disc.

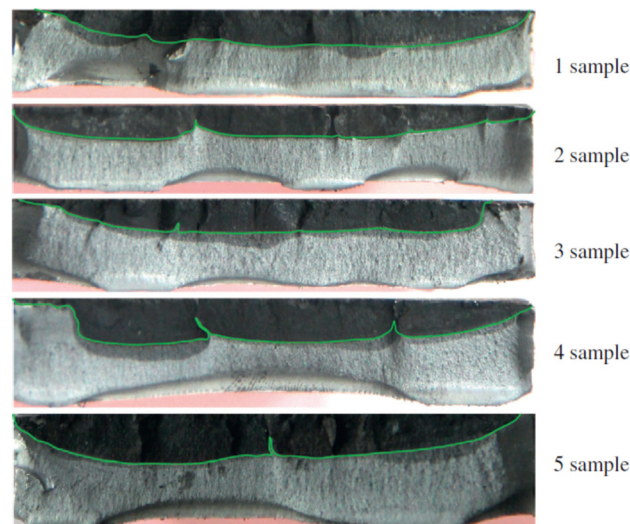
Figure 18. Macro morphologies of the crack fractures [12].

radial axis (more often), due to the different elasticity of the materials used for the discs. The final depth of the crack can differ at different stages of the failure. Finally, a fully developed long crack will reach a similar depth regardless of the mechanism of its formation, and the only difference in the image of the crack will be point “artifacts” in the form of local flattening of the crack (Figure 18, samples 2–5) delineating the boundaries between primary cracks [12]. For this reason, the developed method of crack assessment is universal for practical applications. Moreover, it should be pointed out that the results of the crack shape obtained in the tests are consistent with the results of other studies [5–8,11,12].
